# Workshop on "Radiological characterisation for decommissioning", Studsvik, Sweden 17-19 April 2012

Cristina Correa, Esther García Tapias, José Luis Leganés ENRESA, (Spain)

1. Introduction. PIMIC Decommissioning Project Overview and Lenteja incident.

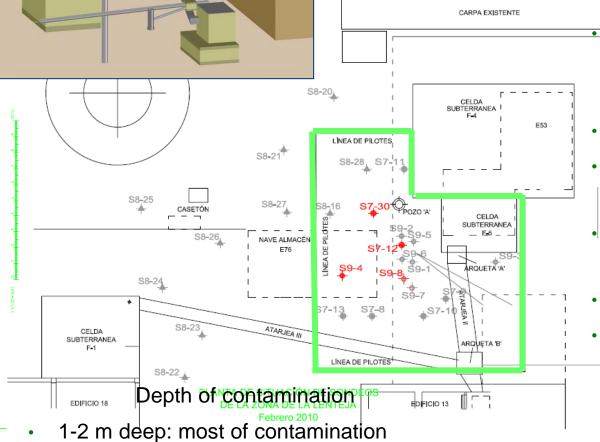
- Three different boreholing surveys were performed (S7, S8, S9; 2004 - 2006).
- Nº of samples: 277
- Main Radionuclides: Sr-90 & Cs-137, Alpha traces
- Range: From "0" up to 10<sup>4</sup> Bq.g-1 of Cs-137 & Sr-90
- Soil Volume estimate: 3,000 m3
- The affected area estimated was of 450 m2 & up to 8 m deep.

- 5 m deep: significantly decreased
- 9 m: less than 1 Bq/g

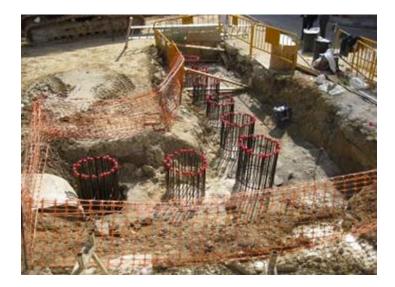
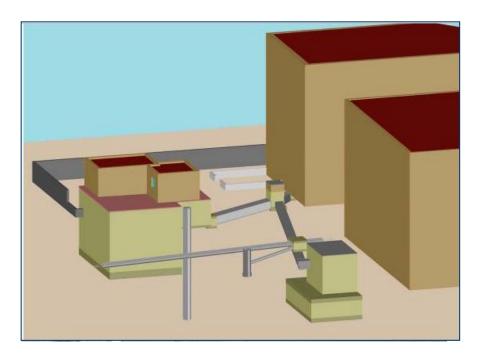
- Structures demolition
- Underground pile wall (50 m perimeter, 15 m deep = 425 m<sup>3</sup>) to content the excavation area

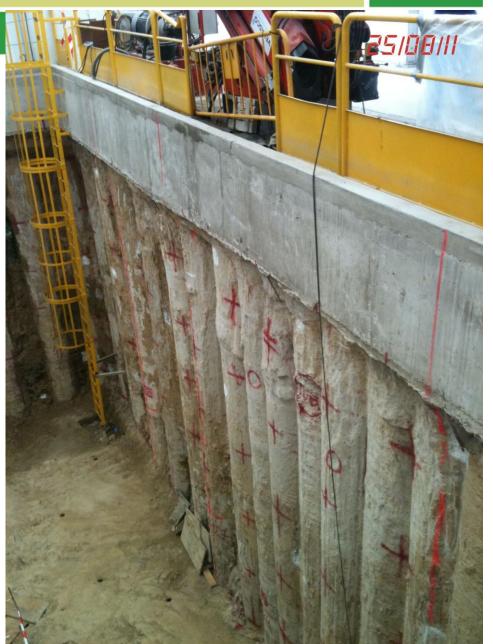
- <u>Wall surface</u>: MARSSIM methodology (Nureg 1575)
  - Scan surface (1 x 1 m<sup>2</sup>) using scintillation counters (beta counter for surface contamination)
  - Static measurements: 13 locations for each survey unit (2)

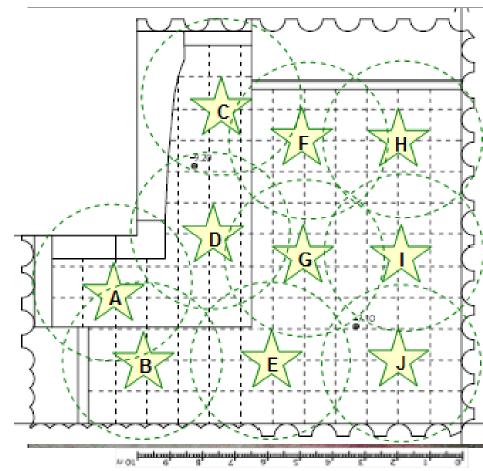
- Soil and subsurface:
- 1. Checking the top 15 cm (MARSSIM methodology)
  - Scan surface (1 x 1 m<sup>2</sup>) by using scintillation counters (beta counter)
  - Scan surface by using INa detector (100 % coverage)
  - Static measurements:15
     locations Sodium iodide
     detector (top15 cm)
