Decommissioning Efforts on Chornobyl NPP site – Past, Present

Viktor Kuchynskyi - Chernobyl NPP, Ukraine,

Mitigation of Chernobyl NPP accident

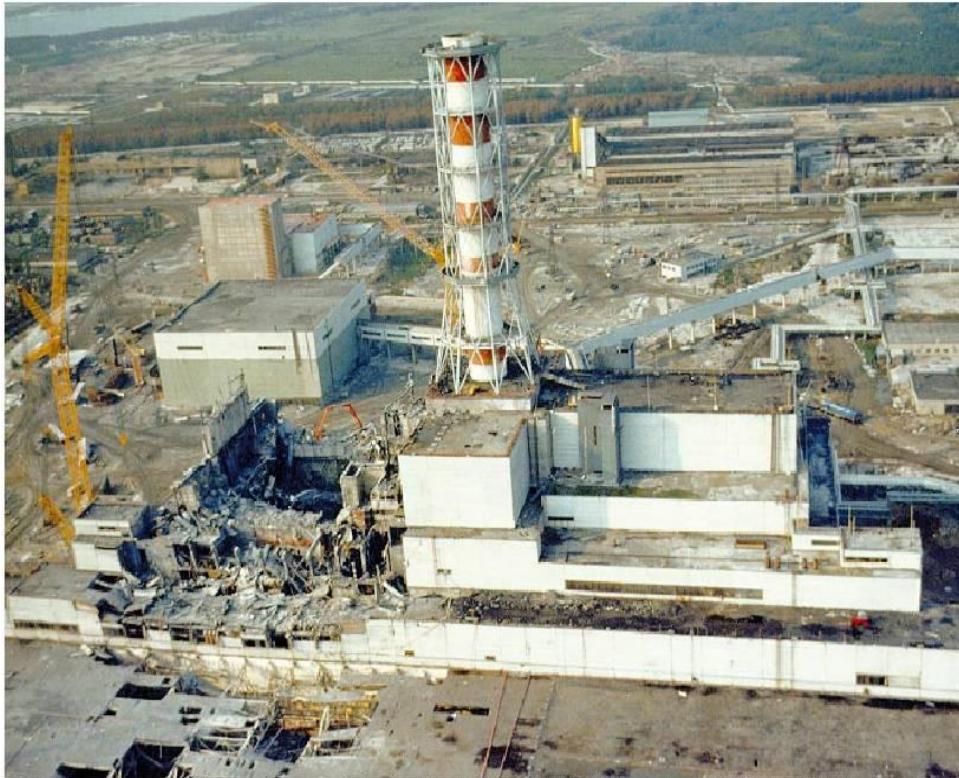
The worst world accident in the nuclear power history occurred at Unit 4 of Chernobyl NPP on April 26, 1986.

- The 7th level of the INES scale was assigned to the accident
- About 50 MCi of radioactivity was released within 10 days
- 200,000 square kilometers were contaminated

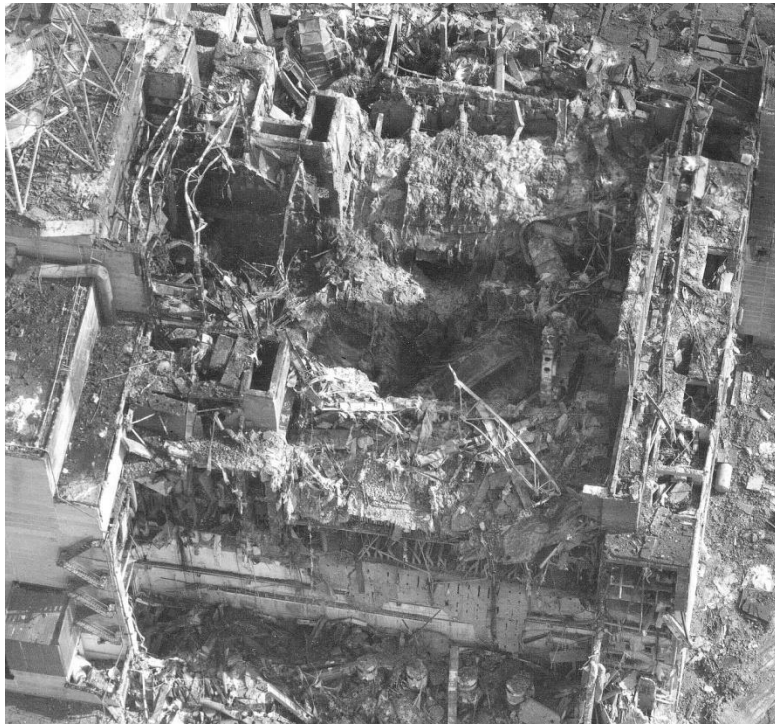
Top filling (plugging) of the reactor

To reduce releases from the destroyed reactor to the environment Governmental Commission decided to drop materials from helicopters into the reactor shaft.

Name of the material	Chemical formula	weight (t)
Boron carbide	B_4C	40
Dolomite	$MgCa(CO_3)_2$	1200
Crushed marble, clay, sand, etc.	-	3500
Lead (fractions + "bars" and others)	Pb	6700
Trisodium phosphate (solution)	Na_3PO_4	2500
Other dust suppression compositions (solutions).	Latex type CKC-65 gp, bard, liquid glass, silicon rubber, etc.	2700
Total		16600

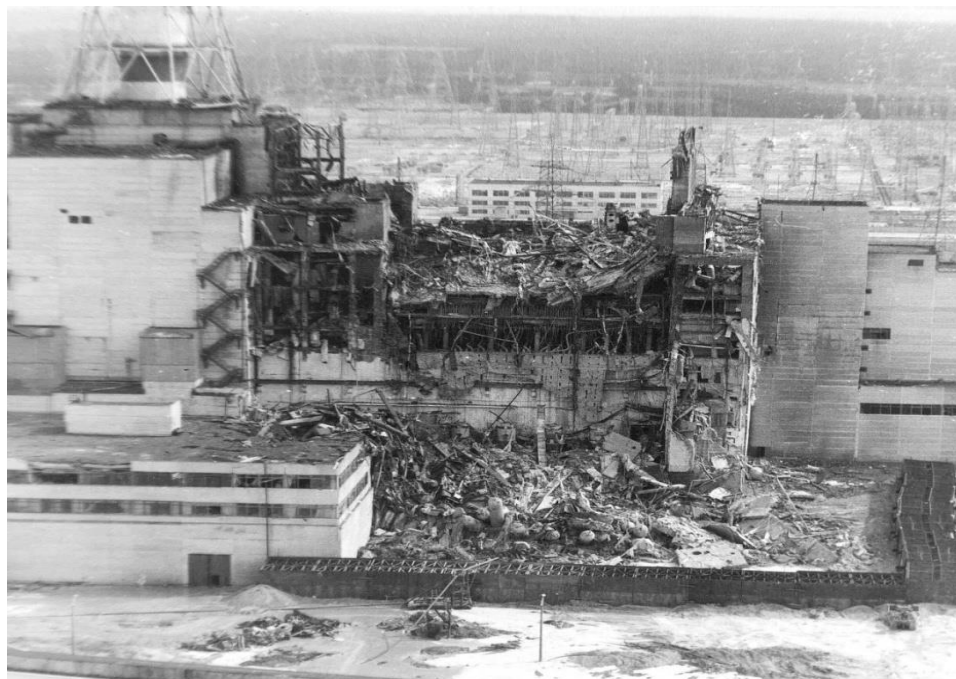
Reducing of the radioactivity level and cleaning of the territory adjacent to the accidental Unit

The dose rate around the reactor compartment walls was 2,000 R/h and along the perimeter of Unit - 200 R/h.

Removal of reactor core fragments, removal of the top soil layer and construction of the concrete "pioneer" walls along the perimeter of the accidental unit improved significantly radiological situation.

High-Level Waste collected from the surrounding area was placed behind the "pioneering" walls.

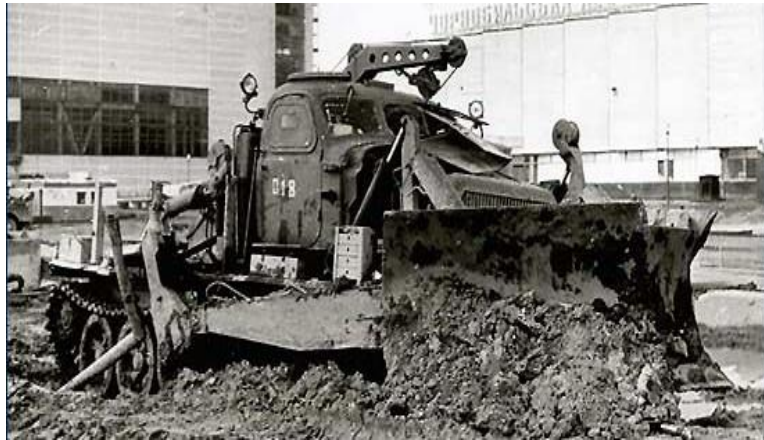
Trail-builder BAT-M was used for work on decontamination of the territory adjacent to the destroyed nuclear reactor. Basically BAT-M was used to remove the top layer of soil. Its weight is 27 tons.

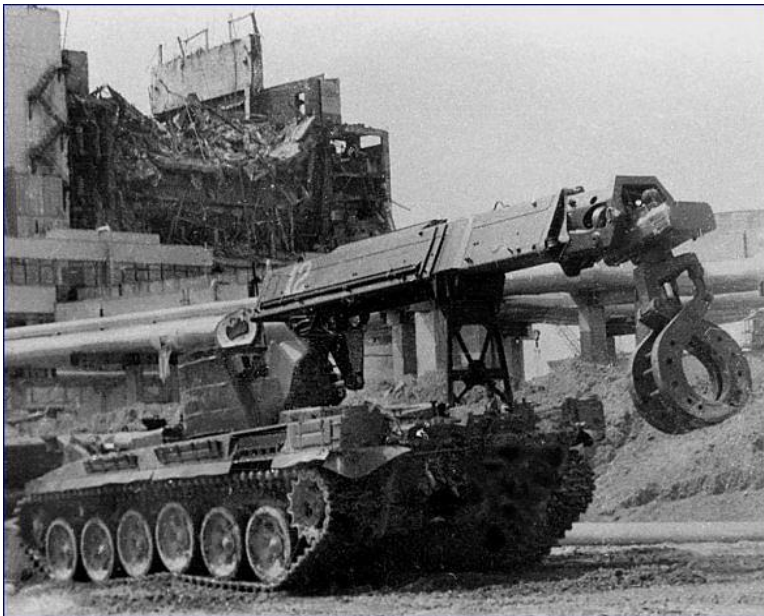
Armoured engineering vehicle AEV played a decisive role in radioactive debris handling around the Unit 4. They are also used to cover the territory with a layer of sand, gravel, and others materials, loading and unloading of containers with radioactive waste. The vehicle was constructed on the basis of the tank T-72A and serially manufactured by IA "Uralvagonzavod" in Nizhniy Tagil.

Its weight is 60 tons.

The radiation dose reduction factor was ~ 100 .

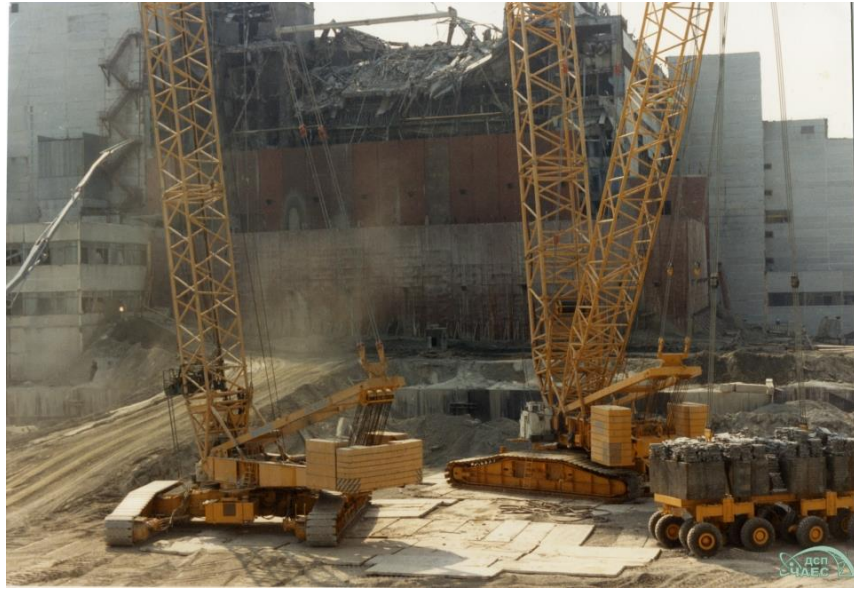
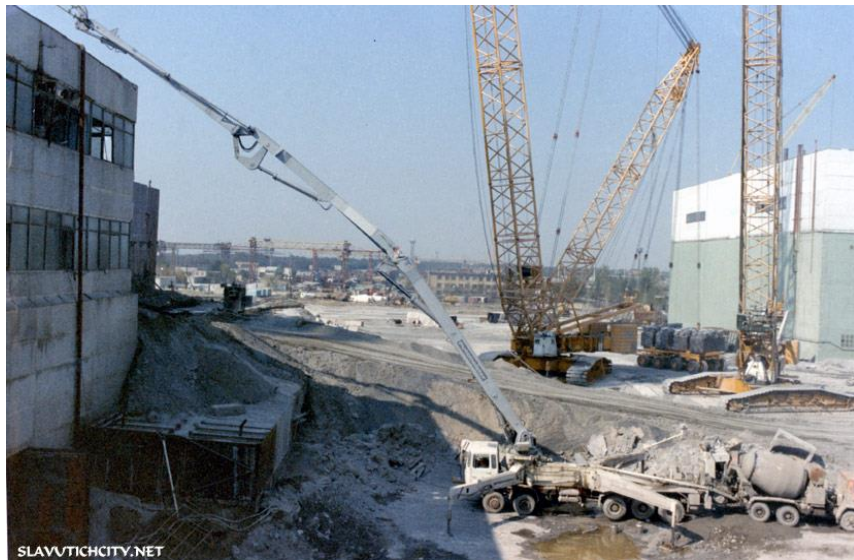
Construction and installation works were carried out using the unique machines and tools:

- crawler cranes «Demag» with a loading capacity on main arm up to 650 tons;
- truck cranes «Liebherr»;
- pumps for concrete mortar supplying, produced by «Schwing», «Putzmeister», «Worthington» companies;
- other machinery and equipment, refitted with remote control and protection equipment.

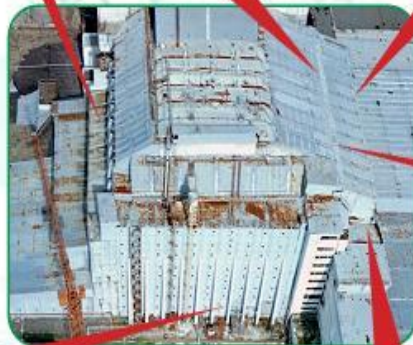
Северная зона.
Объединение контрфорсной стены со щитами-кюшками
Northern Zone.
Connection of Buttress Wall with "Hockey sticks" panels

Shelter object's building constructions do not meet the requirements of normative and technical documentation on safety in parts of the structural integrity and reliability and have an undefined life time. A complex of 8 measures (stabilization) improving durability and reliability of steel structures and building constructions was performed within the period from 1998 to 2008 to reduce the risk of the Shelter object critical structures collapse. Implementation of stabilization measures improved the SO safety level till 2023.

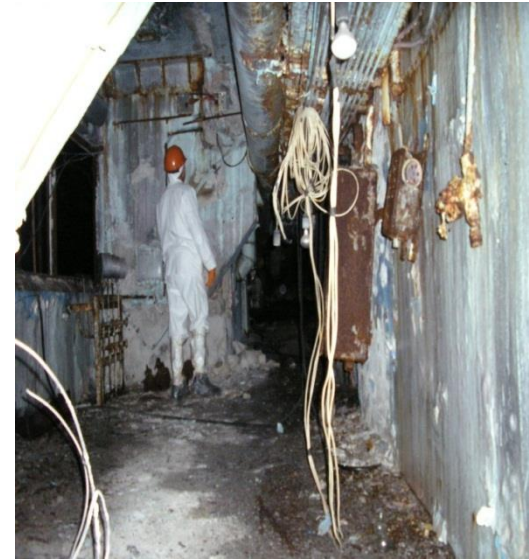
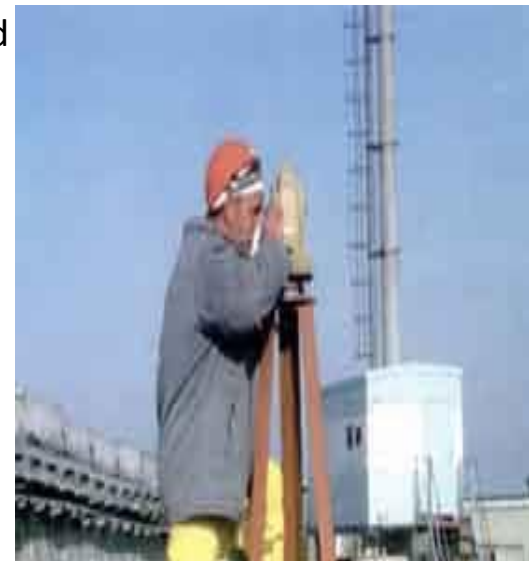
The main objective is to monitor SO and its individual elements deformations and drawdown, identification of the horizontal and vertical movement of the control marks.

- Surveillance on the Shelter object drawdown and deformation is performed on 64 geodetic marks. Beginning of survey - 1986., frequency 1 time every quarter
- Engineering and geodesic works on the instrumental survey of reinforced concrete frame of SO deaerator stake is performed on 26 geodetic marks. Beginning of survey - 1987, frequency once per six months. GPS-technology and tools are used to ensure high accuracy.

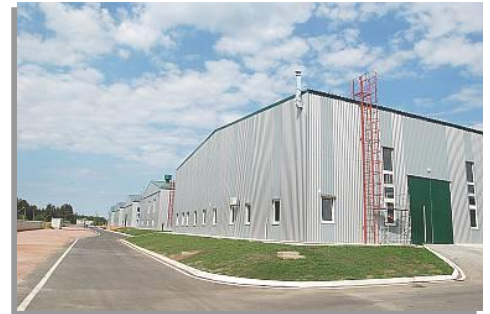
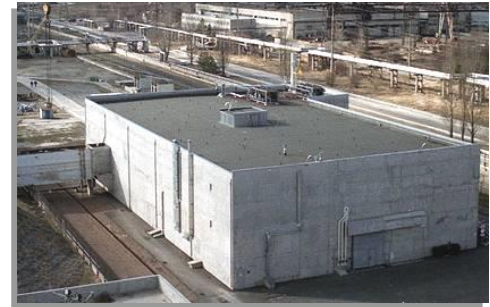
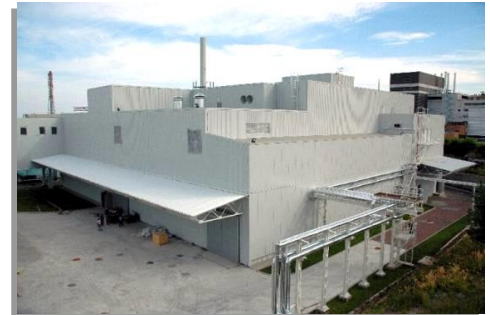
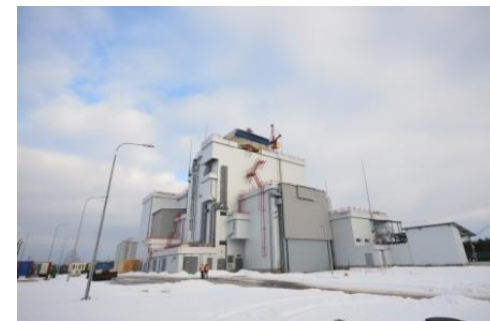
Decommissioning Infrastructure

Complex on Manufacturing Steel Drums and Reinforced Concrete Containers for RAW Storage/Disposal – the facility was commissioned in 2012.

Liquid Radioactive Waste Treatment Plant – commissioned in 2014. Processed first 3.4 m³ of liquid radioactive waste. Obtained the first 40 packages (drums) RW. 4 of them have already been transferred for disposal.

Industrial Complex for Solid Radioactive Waste Management – project is completed. Currently carried out the hot tests. Two of the three stages of the test was successful. The scheduled Complex commissioning – 2017

Interim Storage Facility for Spent Nuclear Fuel (ISF-2) - long-term interim dry storage of spent nuclear fuel from Chernobyl NPP RMBK-1000 reactors. Design service life - 100 years.

Contractor- Holtec International, USA
The scheduled ISF-2 commissioning – 2017.

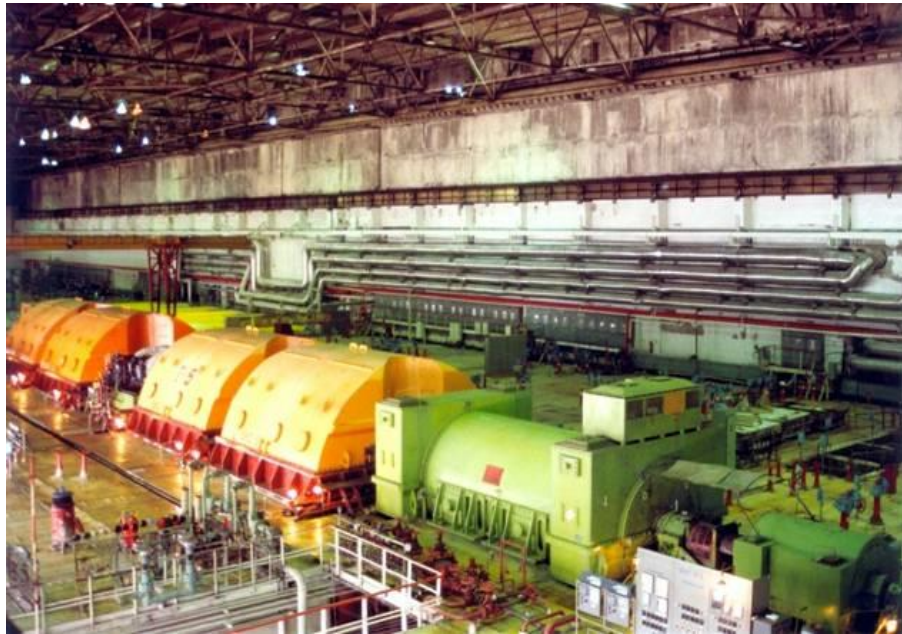
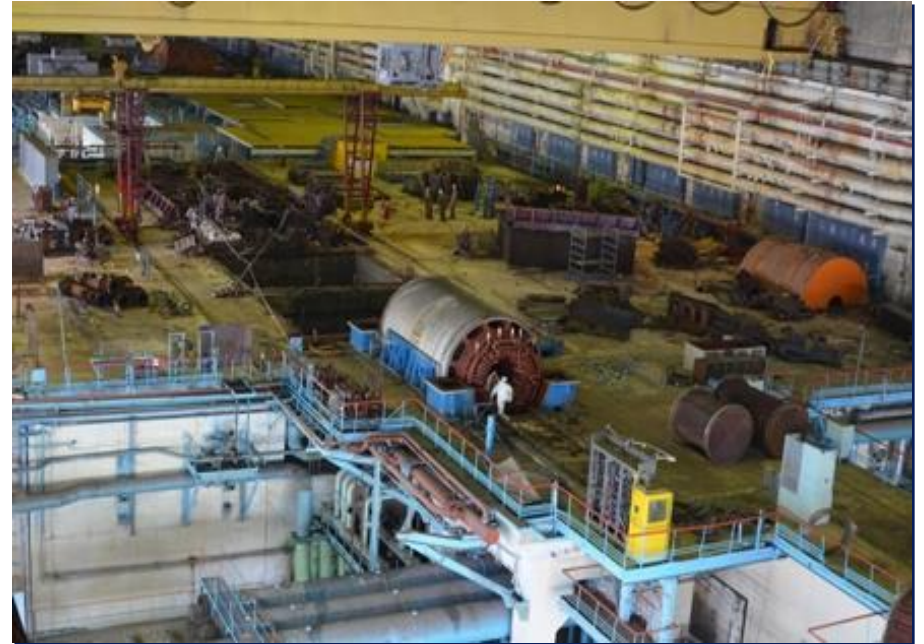
Equipment and pipelines dismantling

Dismantling of the Unit 1 machine hall is scheduled from 2012 to 2017 .

Total quantity of the equipment is 13 900 tons of metal. Currently 5300 t are dismantled by contracting organizations.

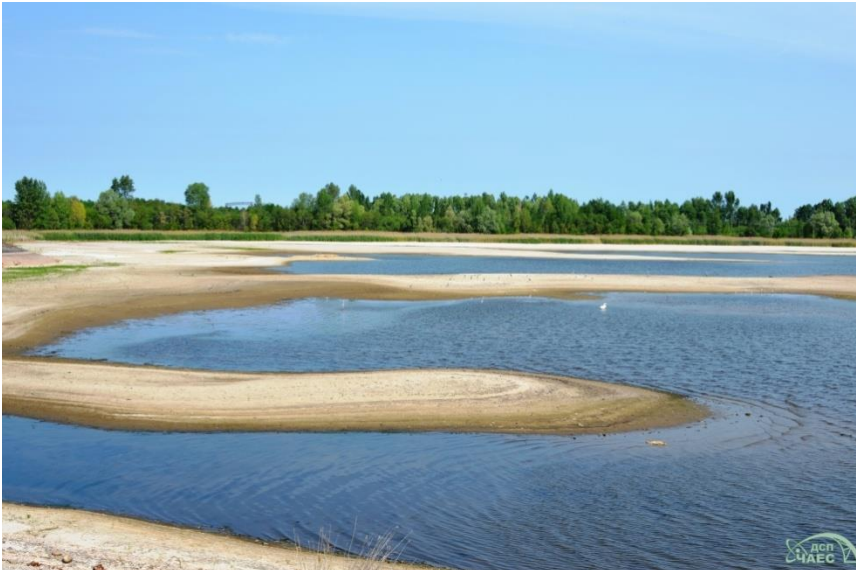
Cooling Pond Decommissioning

Main technical parameters:

- Water surface area – 22.9 km²
- Water level is 7 m higher than the water level in Pripjat river
- Annual costs for maintaining the water level ~ UAH 5 mln.

- A small cooling pond was created – that is a new source of technical water.
- Feasibility Study for the existing cooling pond decommissioning is under expert examination.

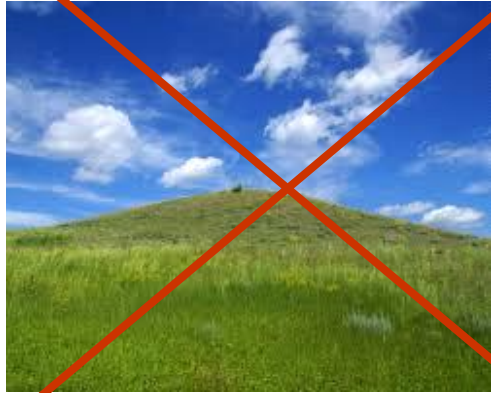
«Green field»
1992

Development industrial site - final status of Chernobyl NPP

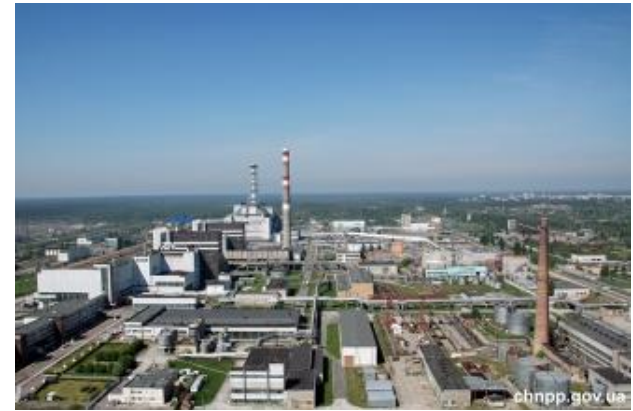
Industrially developed site
2008

Industrially developed site is the best solution for the final status of Chernobyl NPP site decommissioning
