# Workshop on "Radiological characterisation for decommissioning", Studsvik, Sweden 17-19 April 2012

Cristina Correa, Esther García Tapias, José Luis Leganés ENRESA, (Spain)

1. Introduction. PIMIC Decommissioning Project Overview and Lenteja incident.

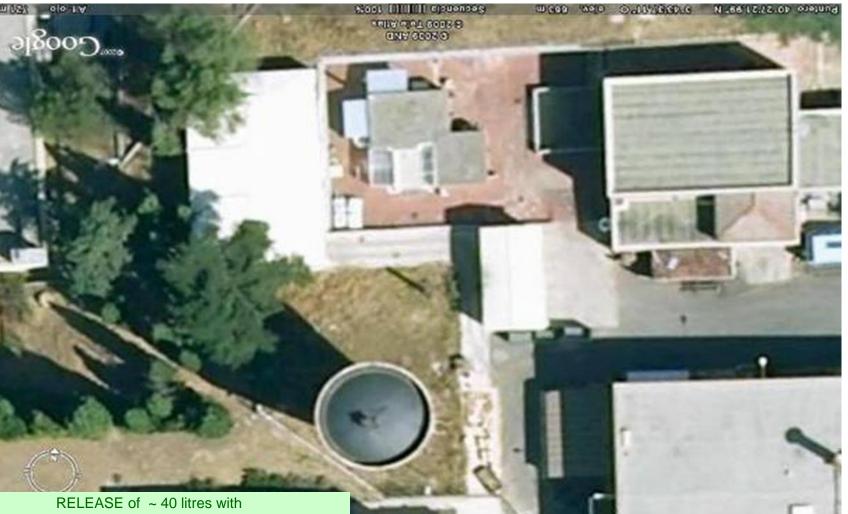
about 25 Ci (9,2E+11 Bq) Cs-137
 about 30 Ci (1,1E+12 Bq) Sr-90

- Soil was contaminated as a result of a pipe leakage, in the 70's
- At that time, part of the soil was removed, filled the holes with clean soil and covered with a concrete slab.
- Some activity remained in the ground.
- In 2010 Enresa started the execution of remediation activities.
- On March 2012 the excavated zone has been refilled

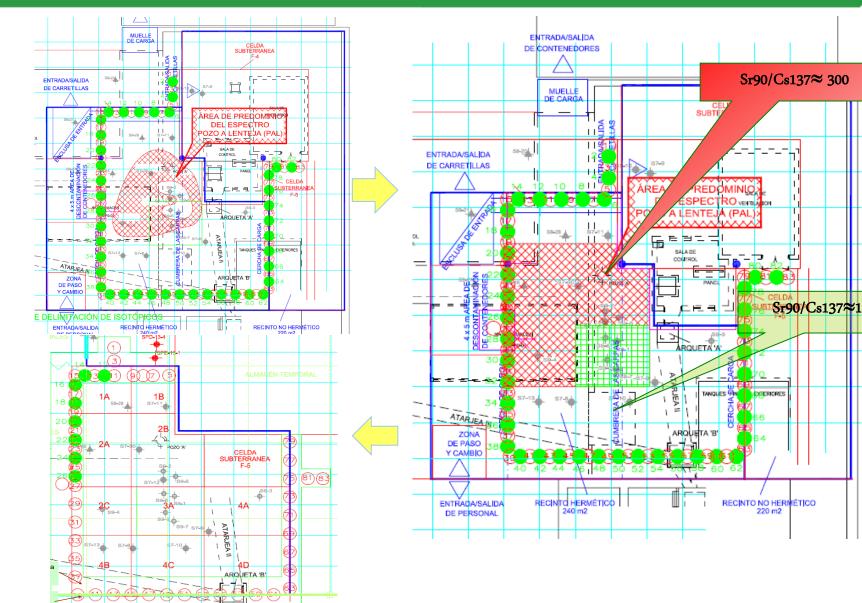
- Three different boreholing surveys were performed (S7, S8, S9; 2004 - 2006).
- Nº of samples: 277
- Main Radionuclides: Sr-90 & Cs-137, Alpha traces
- Range: From "0" up to 10<sup>4</sup> Bq.g-1 of Cs-137 & Sr-90
- Soil Volume estimate: 3,000 m3
- The affected area estimated was of 450 m2 & up to 8 m deep.

- 5 m deep: significantly decreased
- 9 m: less than 1 Bq/g

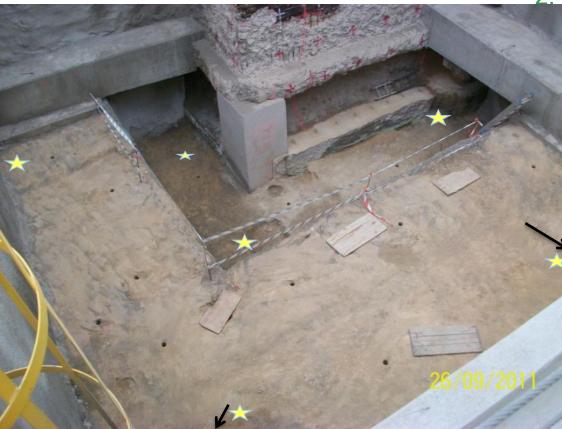
Final radiological survey results:

- 1. Soil and subsurface:
  - The top 15 cm: below release levels
  - No residual activity at depth.
- 2. Walls: residual activity below clearance levels for reuse.
- 3. Walls were insulated using a system of shotcrete.

4. Lenteja excavation was release from radiological requirements and the filling was performed as conventional work.
